INSURV SAFETY CONCERNS

LCDR Angel Salinas

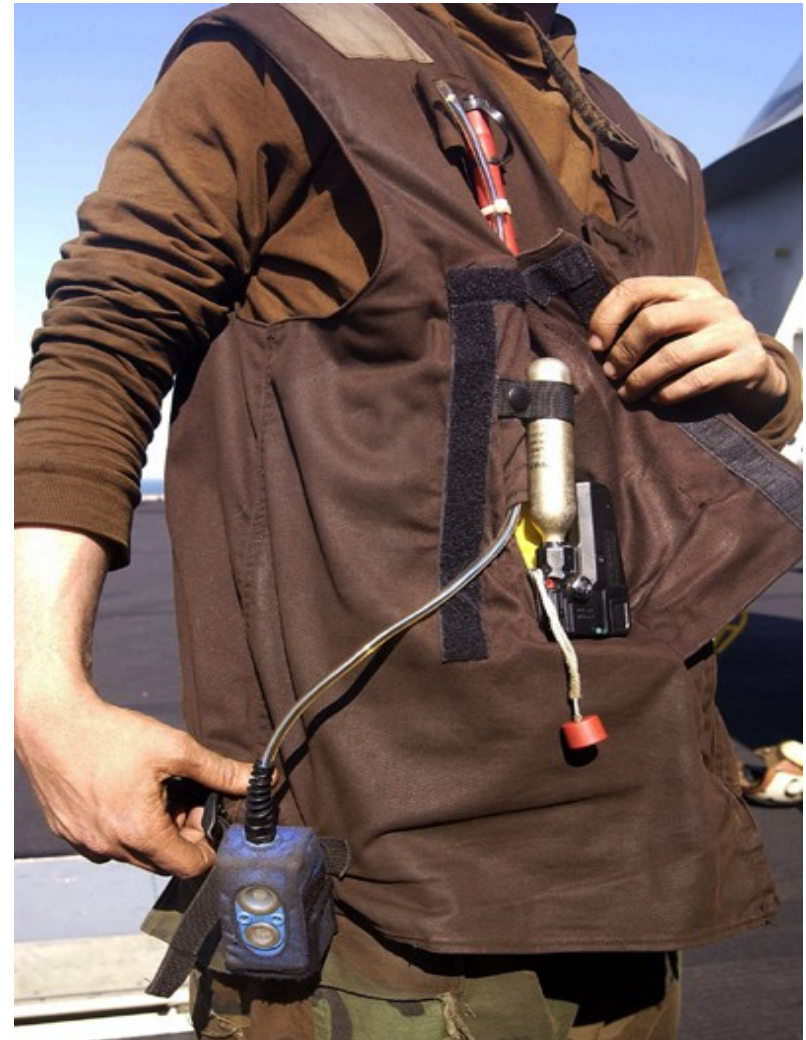
Man Overboard Indicator (MOBI)

- MK1/MOBI Integration being redesigned

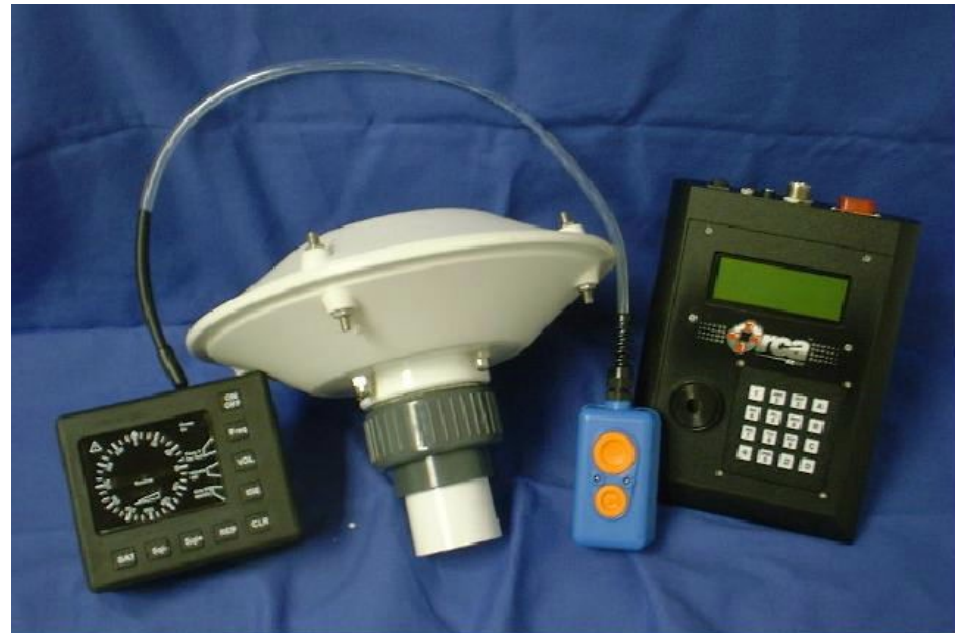
MOBI (CON'T)

- Saltwater or manually activated alarm system that aids in the detection, location, and recovery of a man overboard
- The system consists of a transmitter (TX), receiver (RX), and direction finder (DF)
- TX must be within 1 nm to activate RX
 - Test ship reports ranged in detection from 700 yds to 18 nm
 - Aircraft: 20 nm @ 2000'
 - DF accuracy: $\pm 5^\circ$

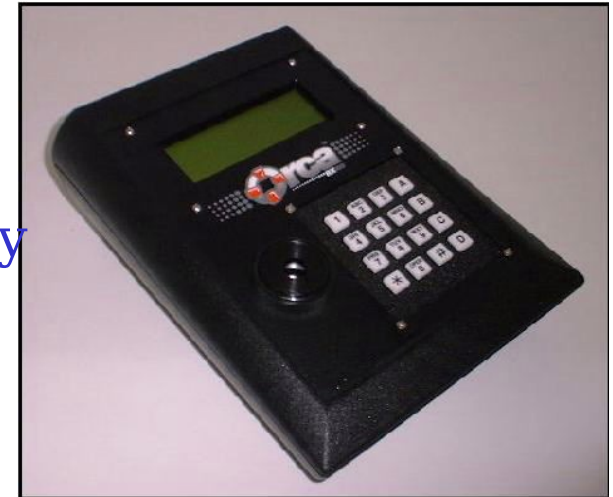
RX Display

- The TX will be configured with the MK-1 life preserver to maximize antenna height above water
- Battery life of 32 hours
- The RX and DF displays can be mounted almost anywhere, with antennas mounted above the bridge and a portable unit for use on ship's rescue boat

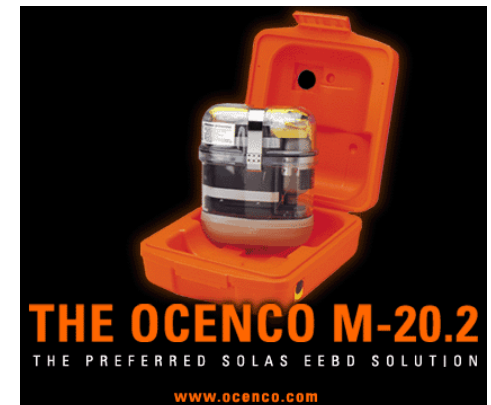
- Ships are in MINIMAL compliance in wearing fire retardant coveralls and SEEDS.
- INSURV inspection data trend shows improvement but compliance is far from 100 %
